PENJAJAWOC STREAM CORRIDOR SURVEY

**BANGOR, MAINE
MARCH, 2024**

PENJAJAWOC Stream Corridor Survey

March 2024

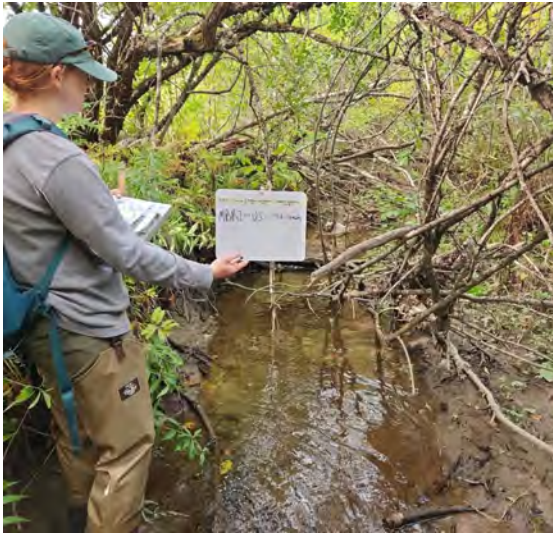
Example of stream shade cover in Reach MB 2A.

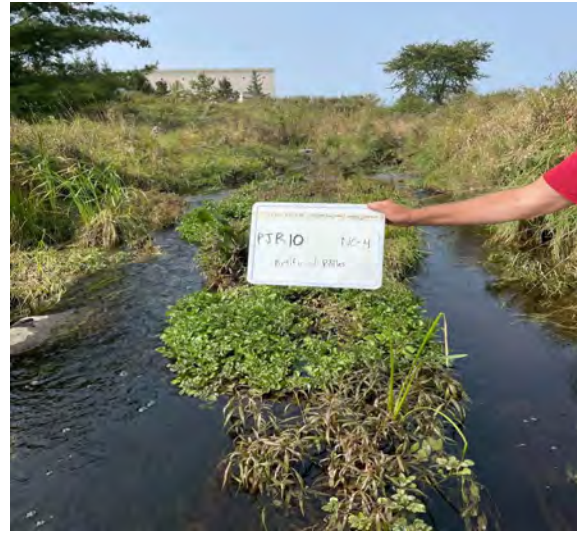
Example of no stream shade cover in Reach PJ 10.

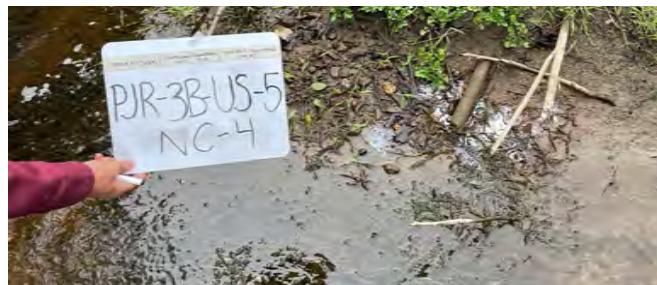
Example of mostly embedded stream bottom in Reach 3B.

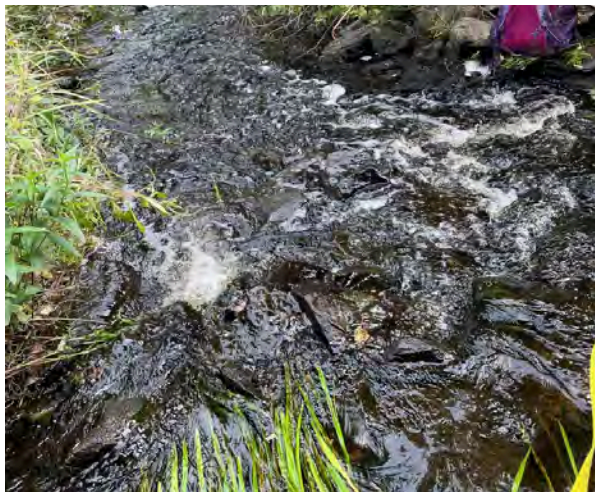
Example of riffles in reach PJ 11.

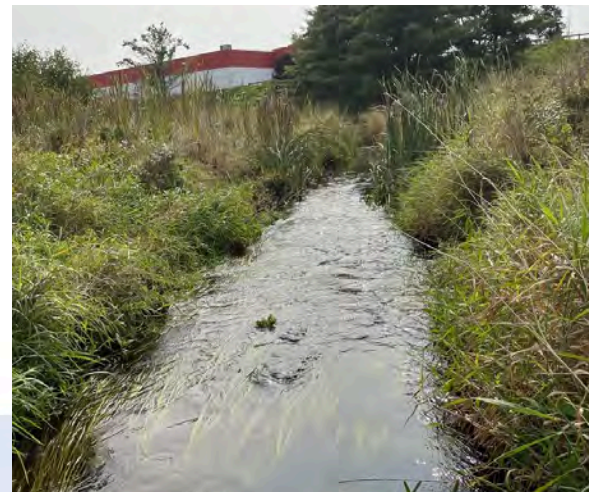
Example of constructed riffles in reach PJ 10.

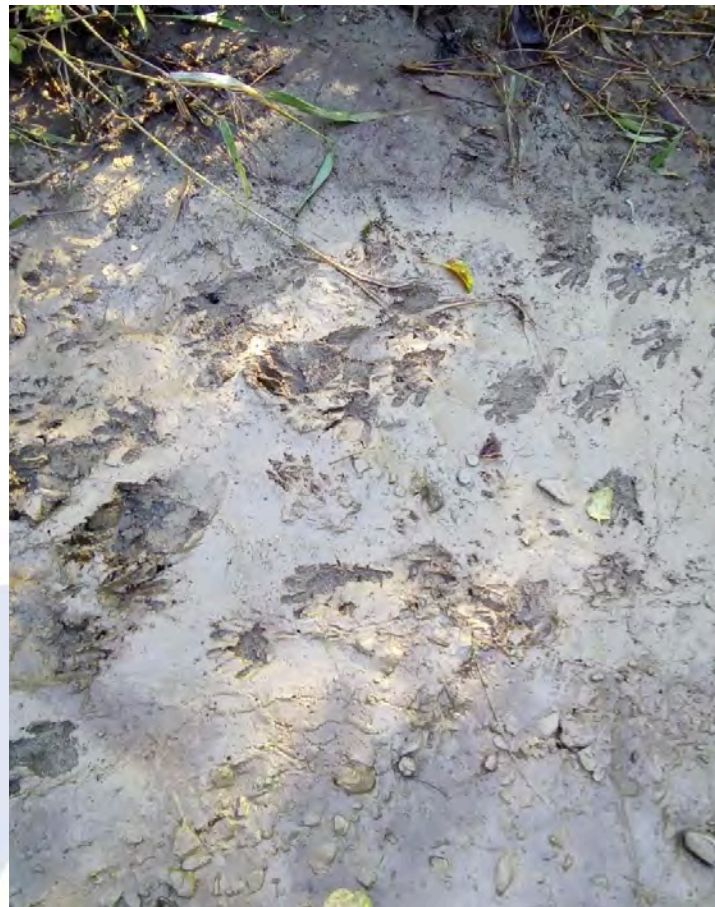
Example of wildlife presence from Reach PJ 4.

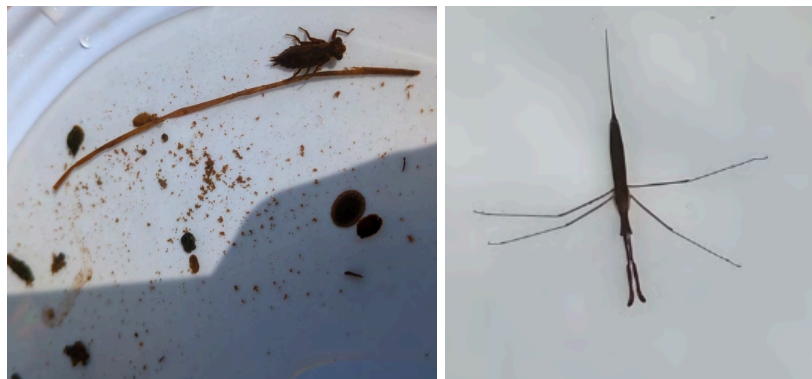
Examples of macroinvertebrates collected during the survey. Left (PJ 5A) and right (PJ PJ 7).

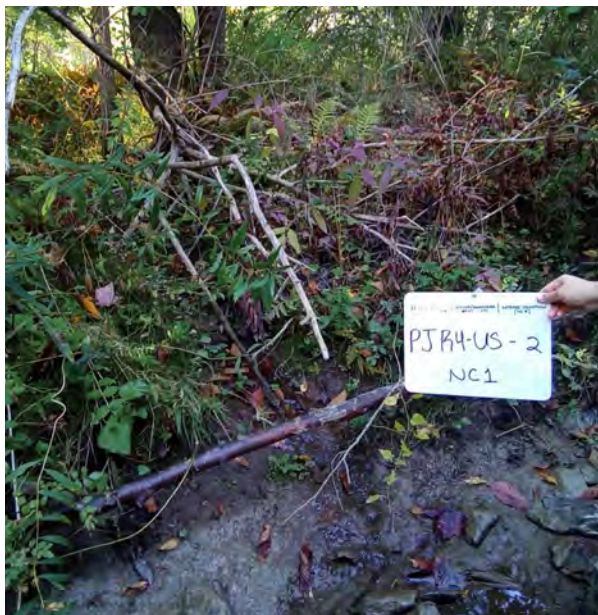
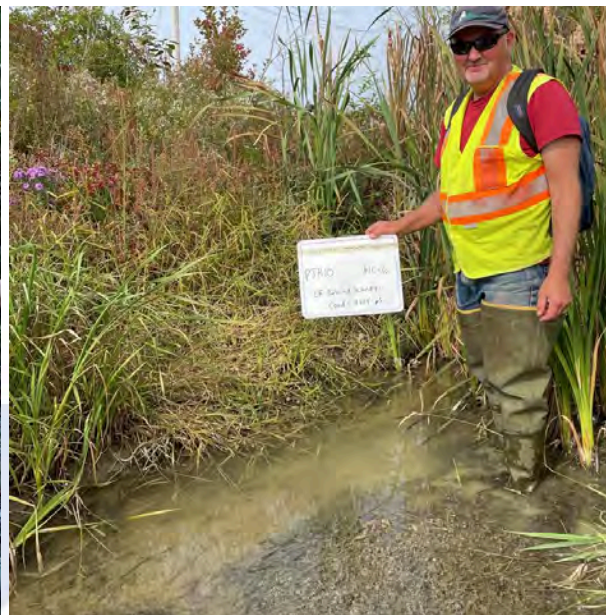
Examples of stormwater outfalls: Reach PJ 4 (left) and Reach PJ 10 (right).

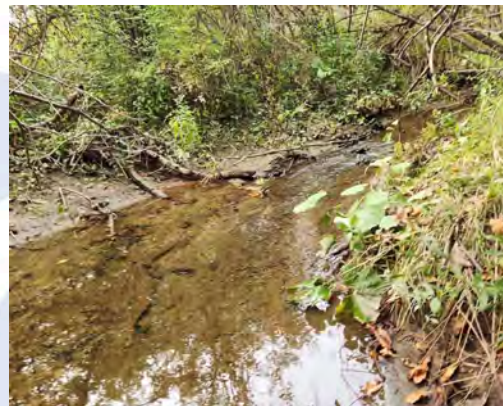
Example of degradation in Reach MB 2A.

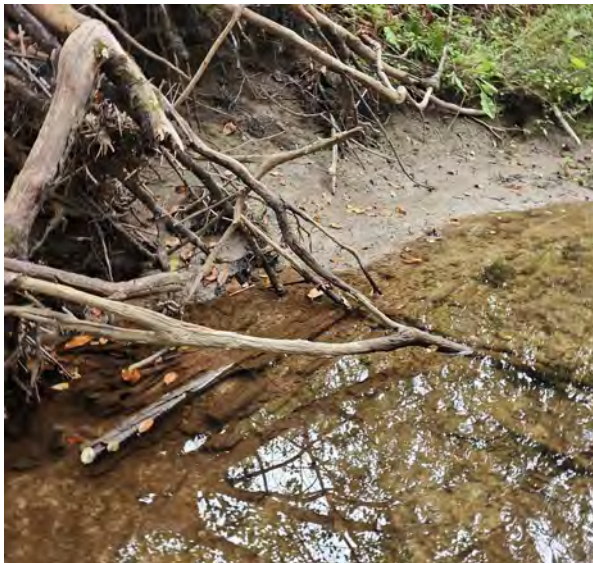
Example of degradation. Image taken within Reach MB 2B.

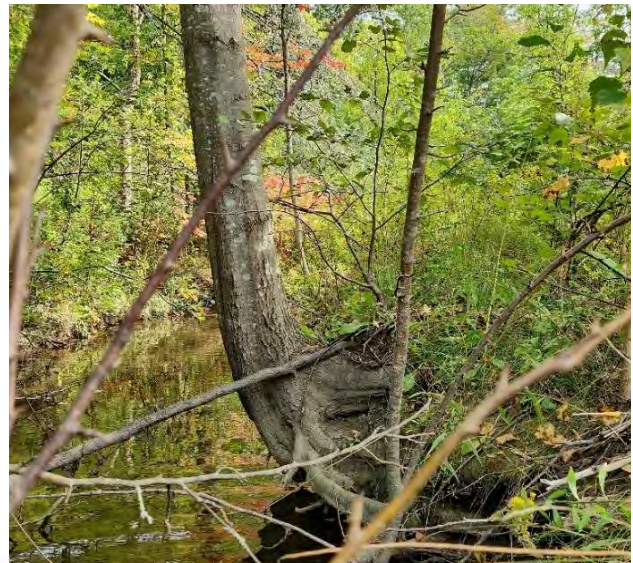
A “J” shaped tree is an example of widening. Image taken within Reach MB 1.

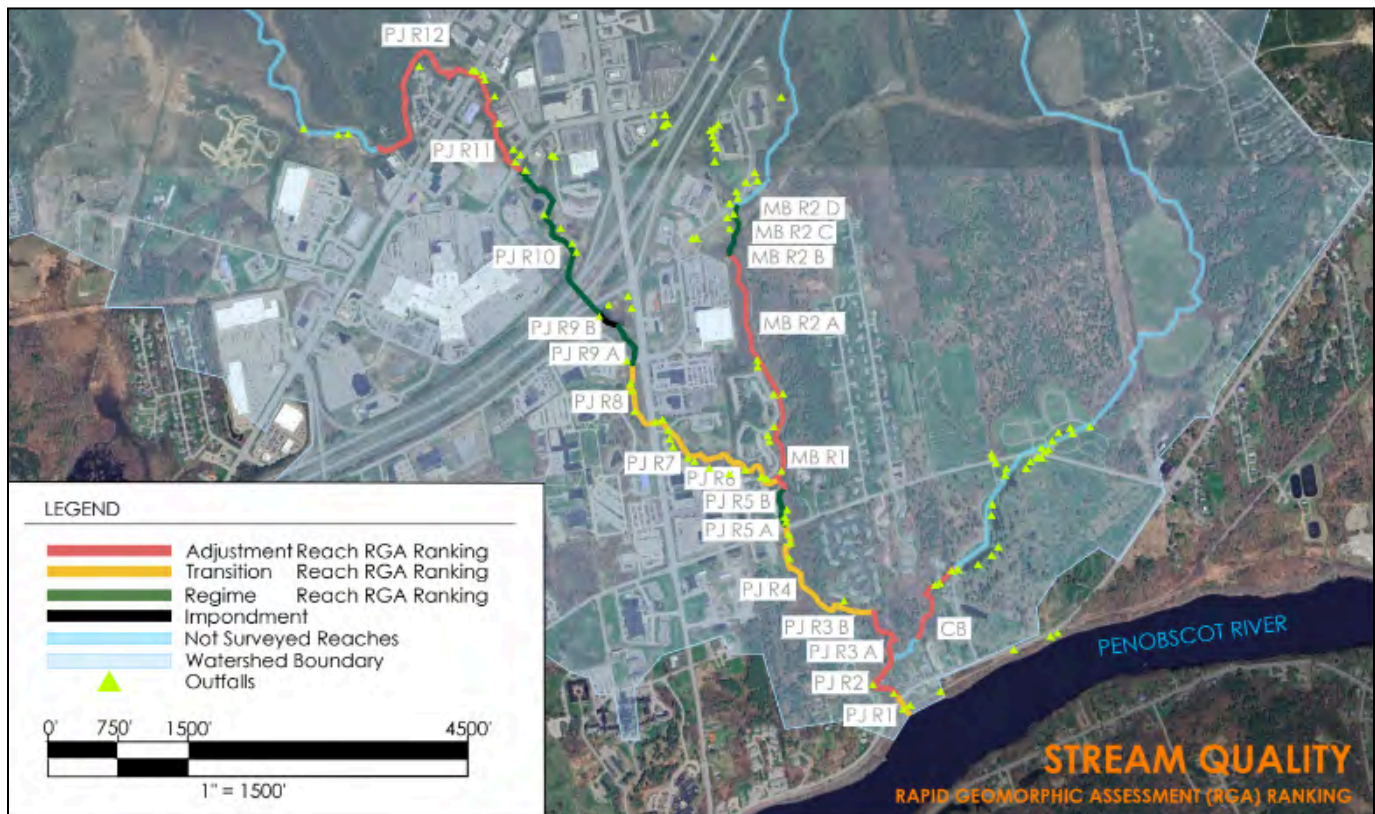
Figure 3: Rapid Geomorphic Assessment Ranking Map

Reaches in adjustment are located near the confluences of Cemetery Brook (CB, PJ 2, and PJ 3A) and Meadow Brook (PJ 5B, MB 1, and MB 2A) and the most upstream reaches of the main stem of Penjawoc Stream (PJ 11 and PJ 12). The in adjustment, in transition, and in regime reaches were scattered throughout the length of the Penjawoc Stream as seen in **Figure 3**, below. A more detailed examination of these results is included in Section 6 below.

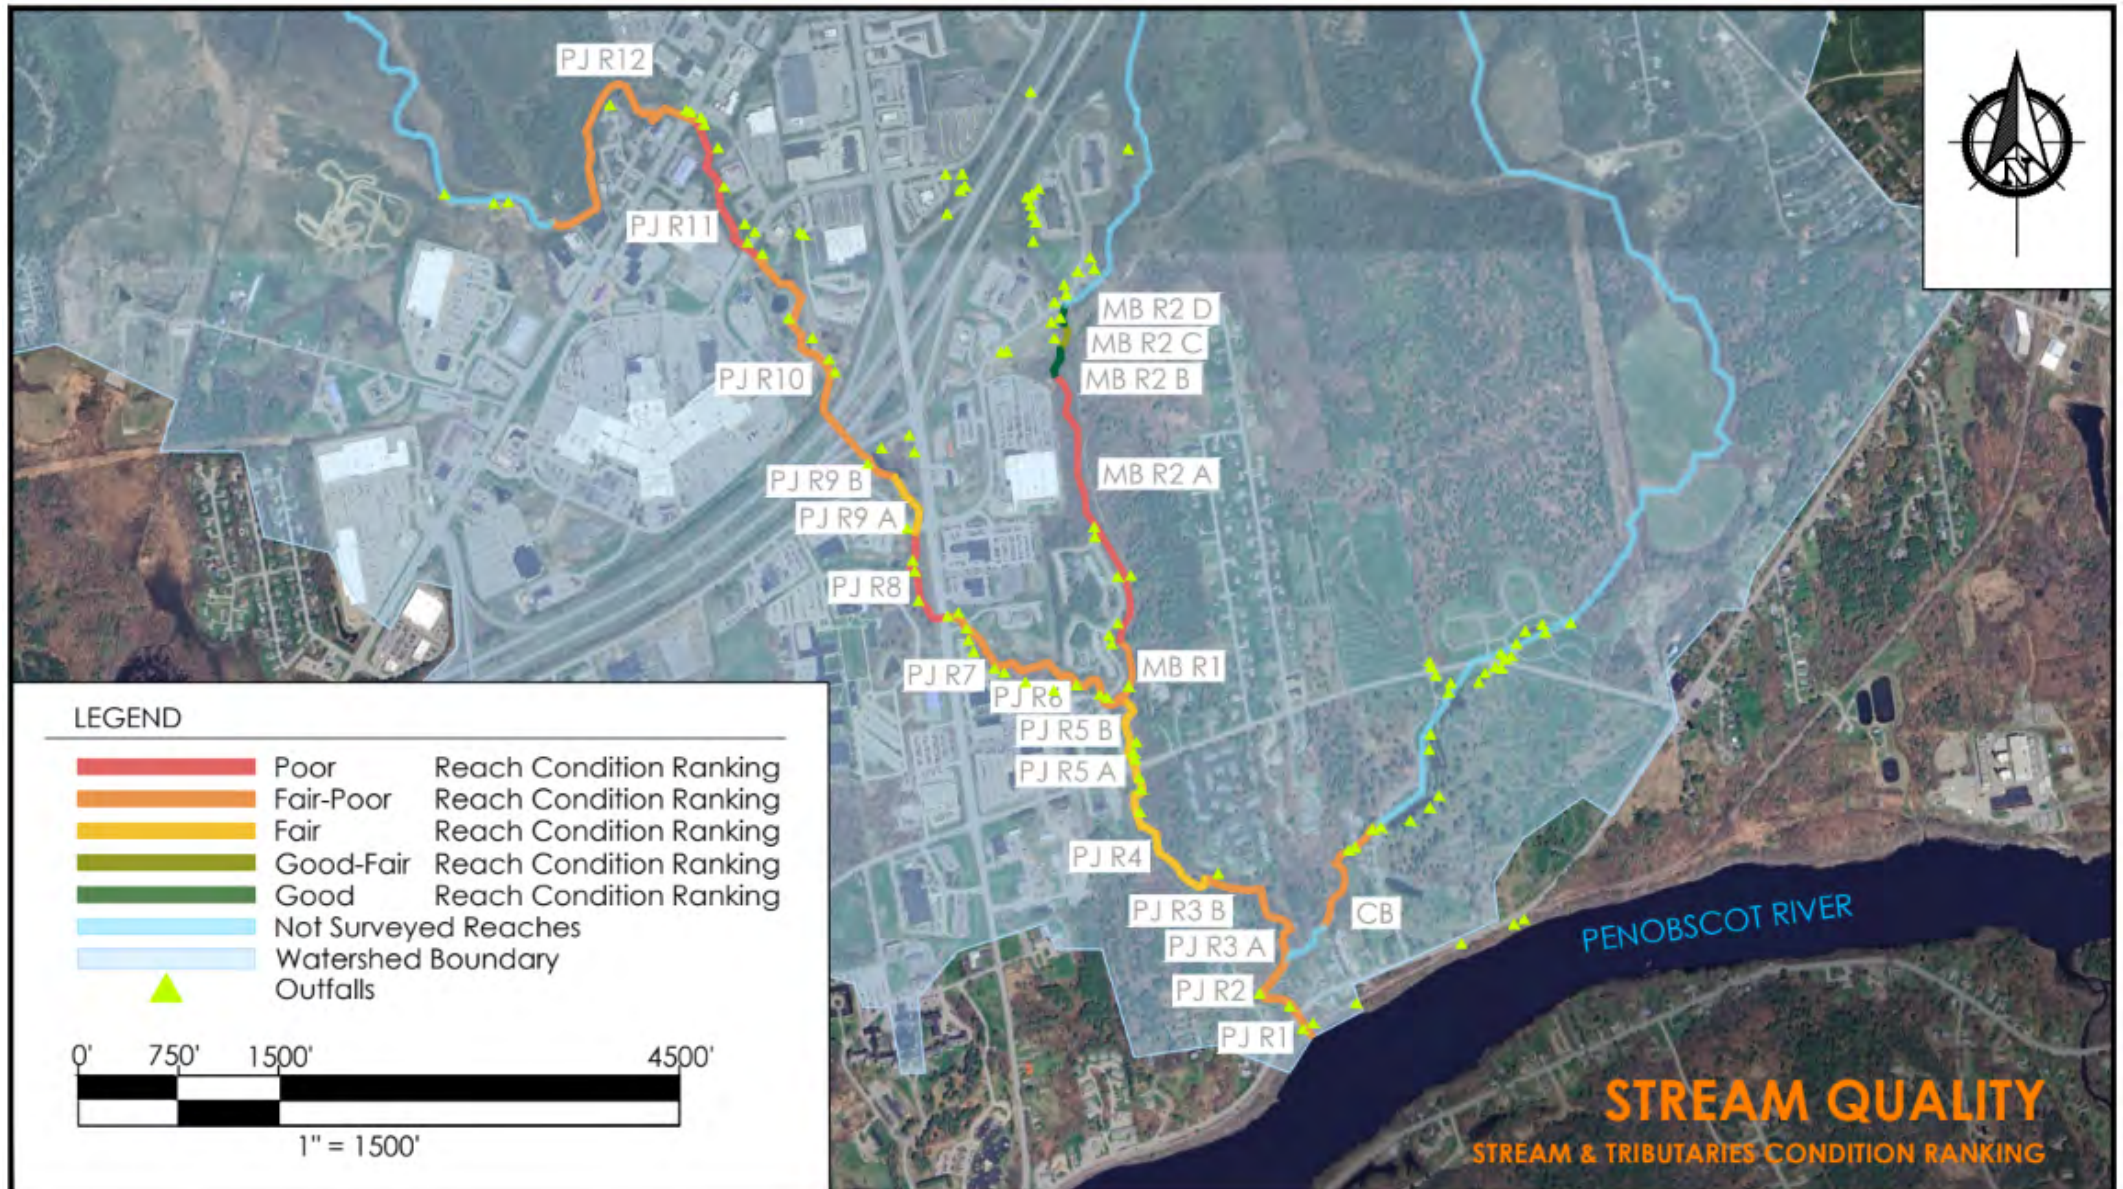
Figure 4: Penjajawoc Stream and Tributaries Condition Ranking Map

Following a review of the compiled scores from the 2023 Stream Corridor Survey, we determined that the overall condition of the stream is fair (**Figure 4** and **Table 2**). Penjajawoc Stream is impaired due to the high amount of development and impervious cover within its watershed (MDEP, 2023). This impervious cover along with the 73 stormwater outfalls discharging into the Penjajawoc and its tributaries are major contributors to the "Fair" ranking.

The City is currently in the process of developing an updated Watershed-Based Management Plan (WBMP) for the Penjajawoc Stream. This plan will provide recommendations for addressing the water quality issues documented during this survey. The next steps for updating the WBMP include a watershed chloride assessment, an updated impervious cover GIS layer, a stressor analysis, and an assessment of the Stormwater Best Management Practices currently in use in the watershed. These assessments along with the SCS and a public process with local experts and stakeholders will allow the City to develop strategies for improving water quality and habitat in the stream over the next decade.
