HISTORIC PRESERVATION COMMISSION

CITY OF BANGOR

HISTORIC PRESERVATION COMMISSION
MEETING OF MARCH 12, 2026, 7:00 P.M.
COUNCIL CHAMBERS, CITY HALL
73 HARLOW STREET

2. **Certificate of Appropriateness – 62 High Street – Map-Lot 042-102 – High Street Historic District – Applicant: Louie Morrison – Owner: Gilpin Holdings, LLC -**

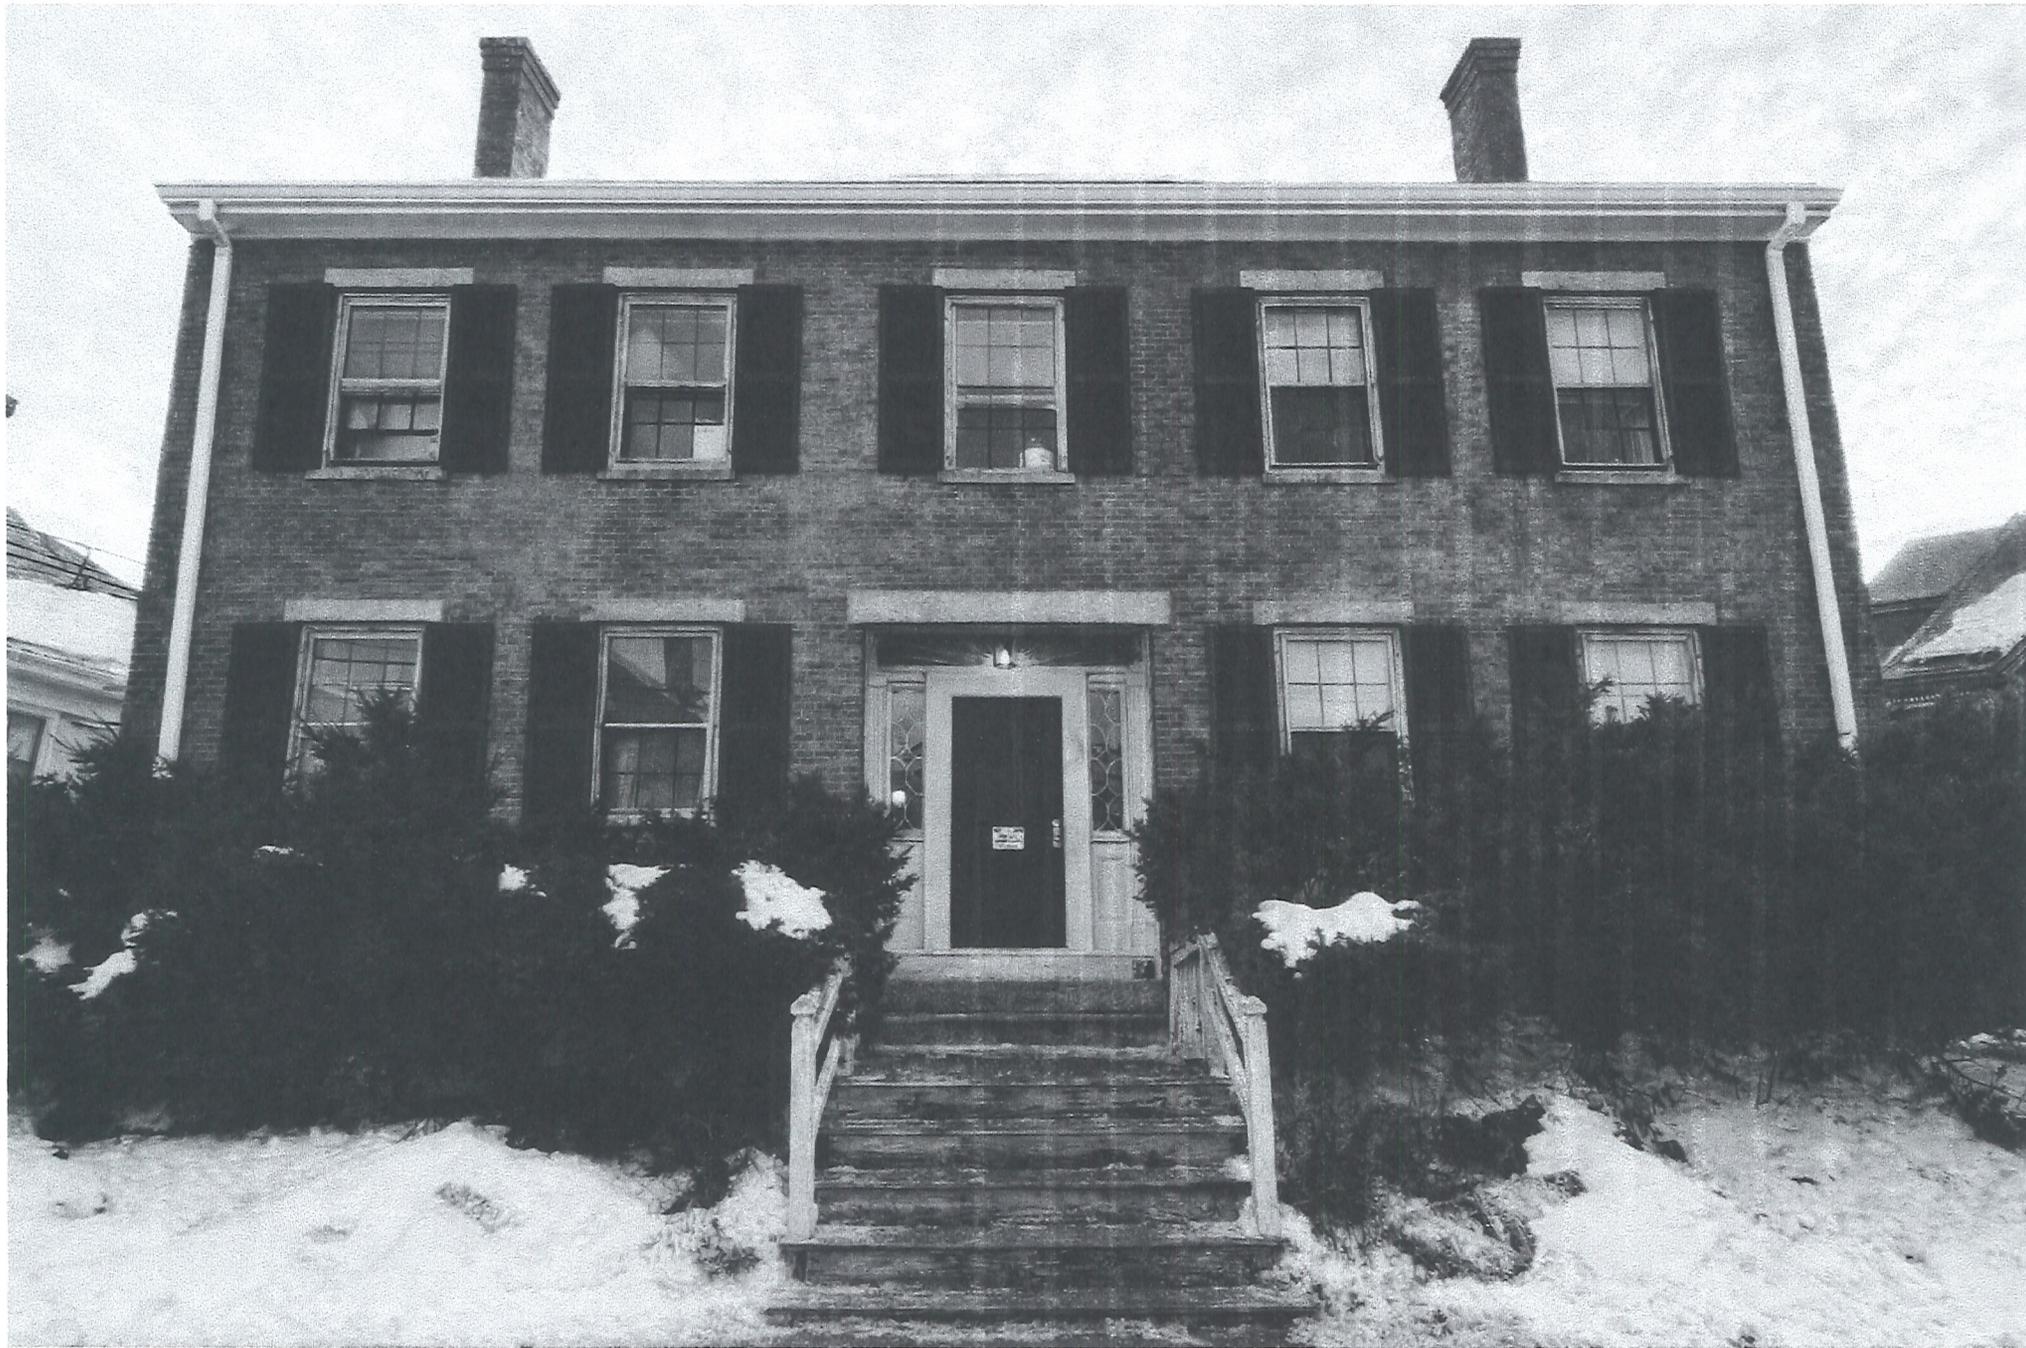
PROPOSED w/ new gutters & trimboards w/ cornices!

Description: Removal & replacement of rotted trim boards & non-functioning gutter system and addition of 4 wood cornices

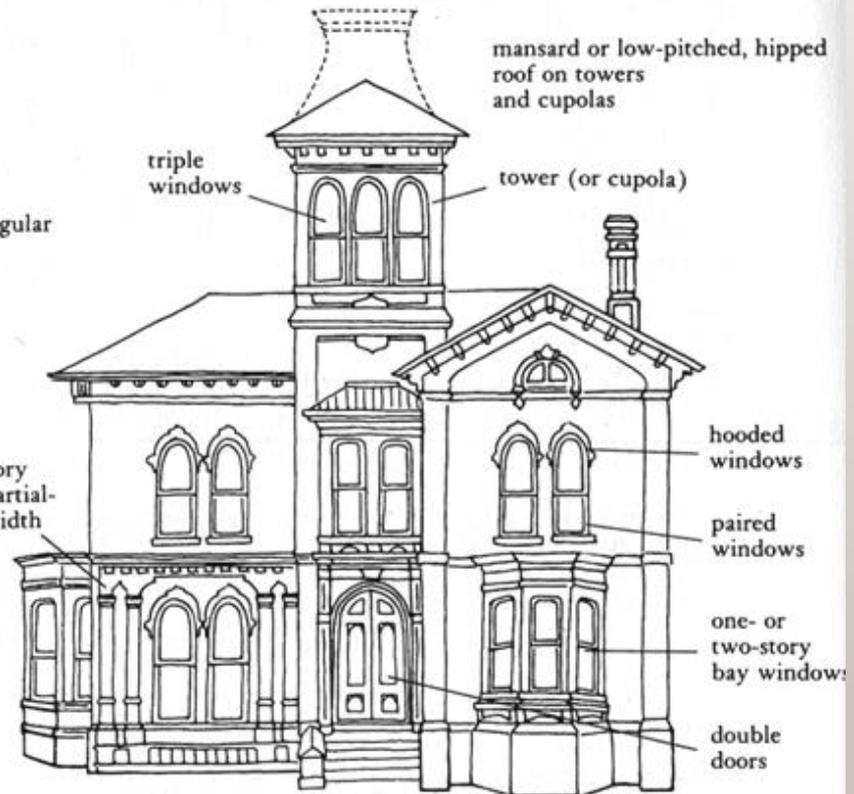
FORMAL RENAISSANCE REVIVAL

rusticated basement or first floor

mansard or low-pitched, hipped roof on towers and cupolas

triple windows

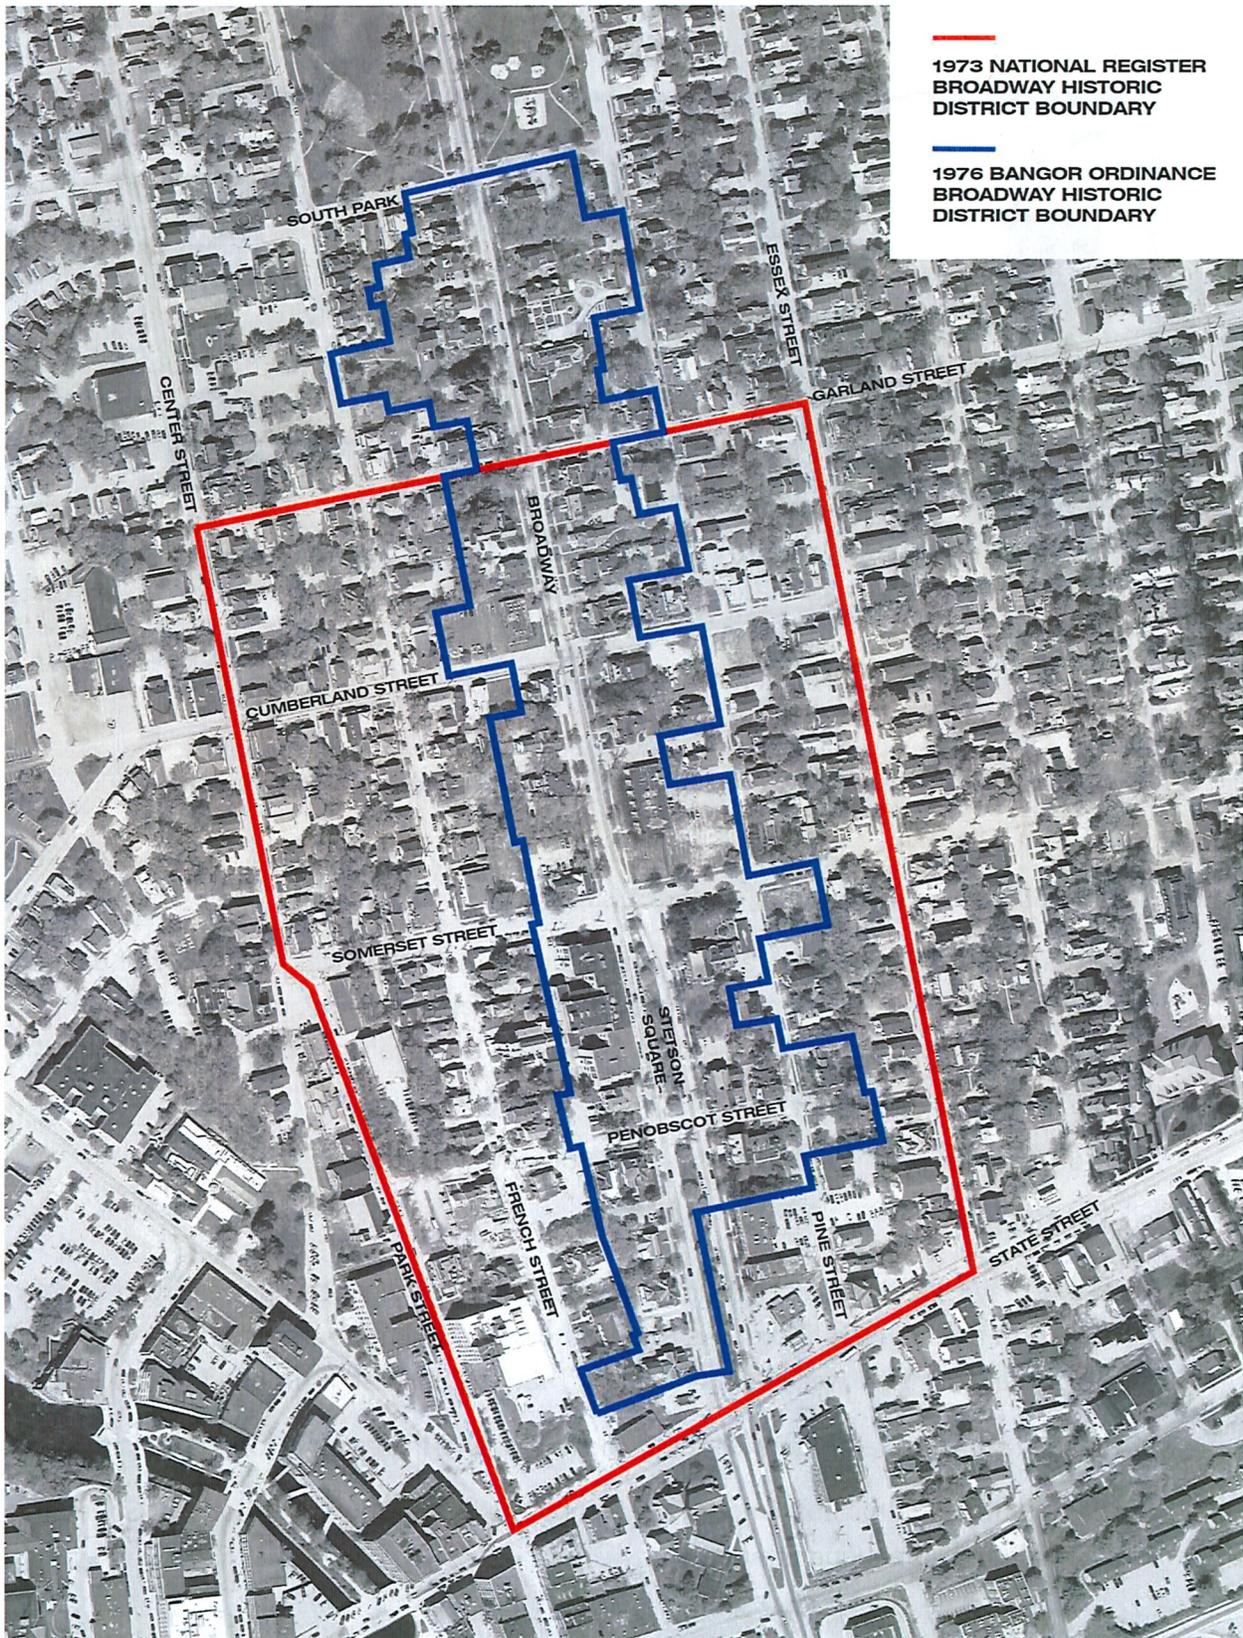
Figure 1 - Broadway Historic District Boundary Comparison

The 1973 National Register Nomination of the Broadway Historic District (figure 1,2) describes eighteen (18) properties located within a broad district encompassing streets on either side of Broadway north of State Street. However, the 1973 National Register district does not include the section of Broadway between Garland Street and South Park Street.

The Broadway Historic District, as designated under the ordinances of the City of Bangor in 1976 (figure 1), is a much more compact district than the district registered with the NRHP in 1973 and is mostly centered on Broadway. The local Bangor district includes the portion of Broadway between Garland Street and South Park Street.

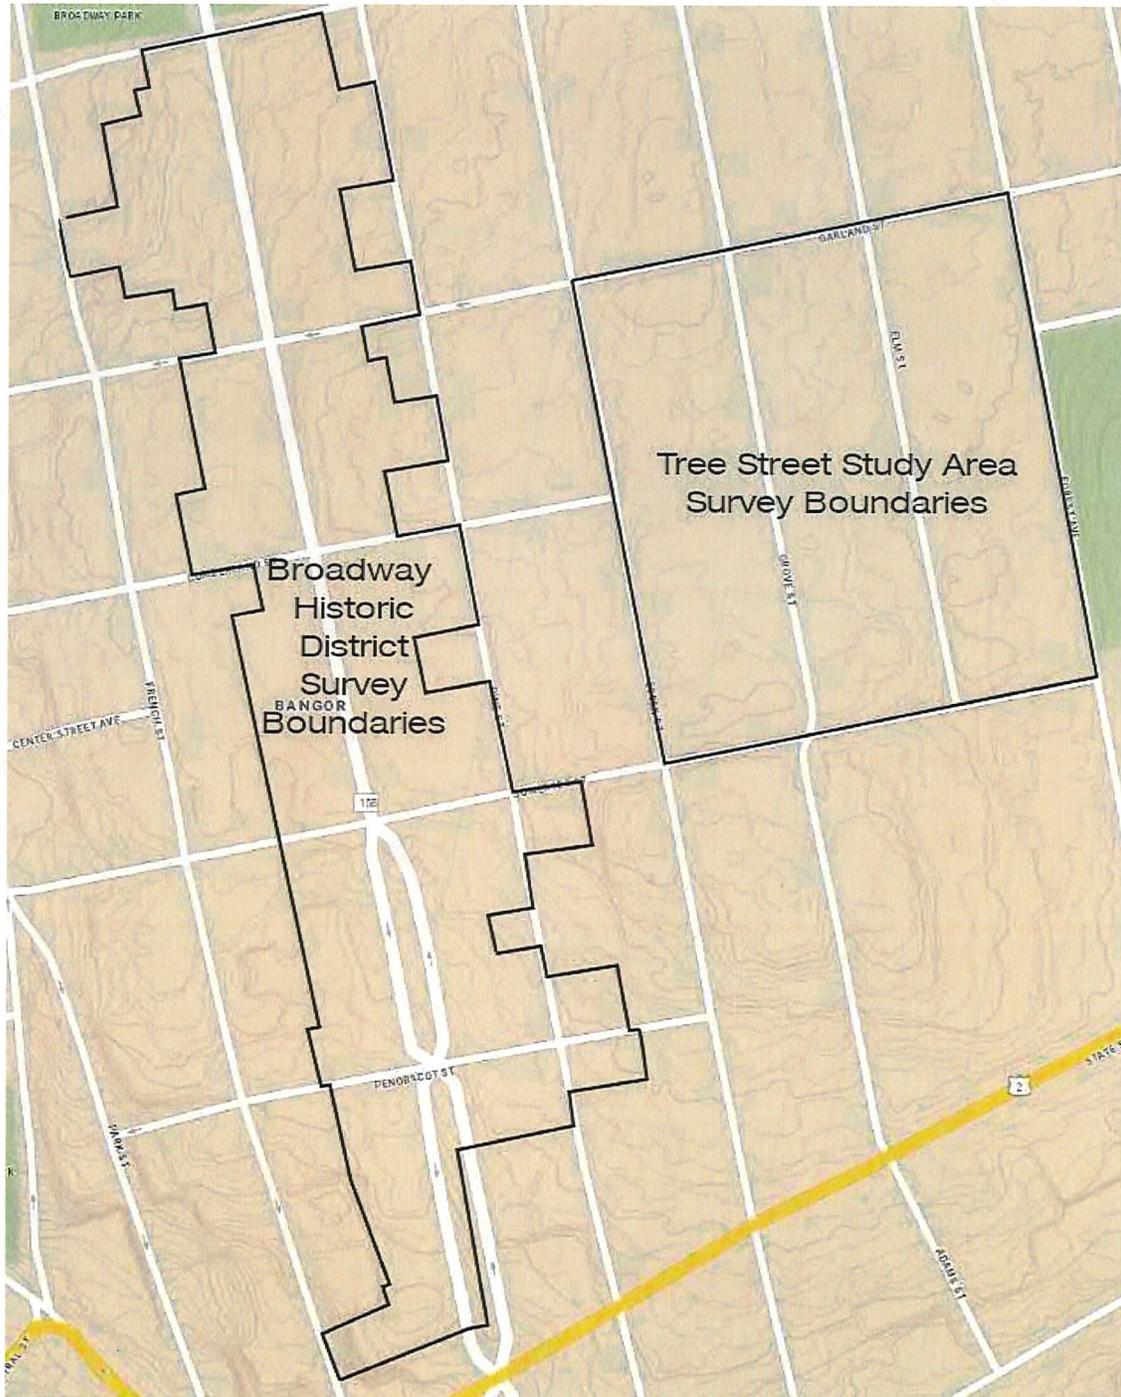
Figure 3 - Boundaries of Current Study Including 1976 Bangor Broadway Historic District

The survey boundaries for the Tree Street Study Area are bounded by the south side of Garland Street to the North, the East side of Essex Street to the West, the North side of Somerset Street to the South, and the West side of Forest Avenue to the East.

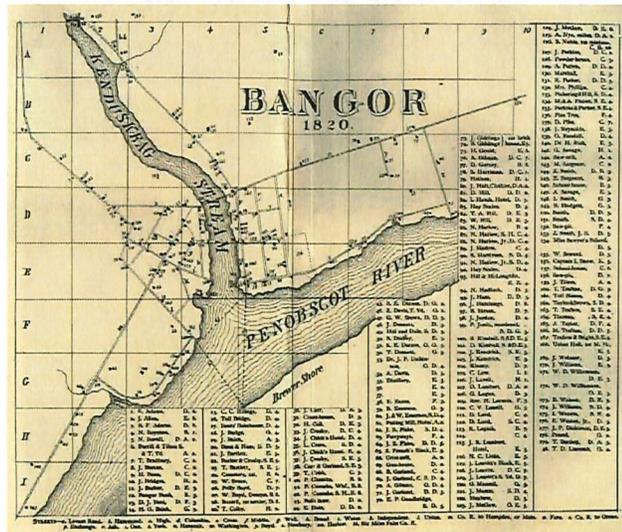
Figure 6 – 1820 Bangor Map

The first evidence of the execution of the Bulfinch plan is found in a map of Bangor dated 1820. Here is shown the beginnings of the grid layout being implemented from the Penobscot north to the "County Road to Orono", which is present day State Street, and bound to the east by Oak Street.

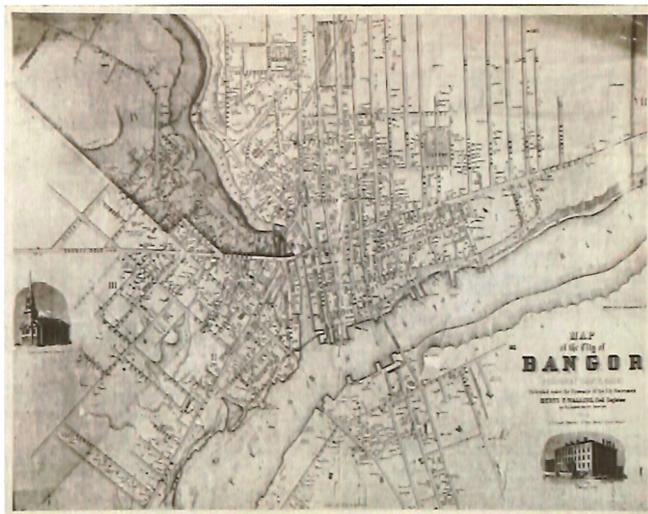
Figure 10 – 1853 Henry Walling Map

The 1853 Henry Walling map depicts the streets of the Broadway District and the Tree Street study area in their current states. Above Somerset Street, Grove became Bannister Street. Forest Avenue is titled Lime Street. Cumberland Street is indicated as the northern boundary of City Common (now Coombs Street). Cumberland also begins to cut into neighboring blocks. The significance of the trees lining Stetson Square is referenced here by their inclusion. Certain homes currently existing on Broadway may be found on this map.
